# **Flood Investigation Report**

**Various Locations, Solihull**

**27<sup>th</sup> May 2018**

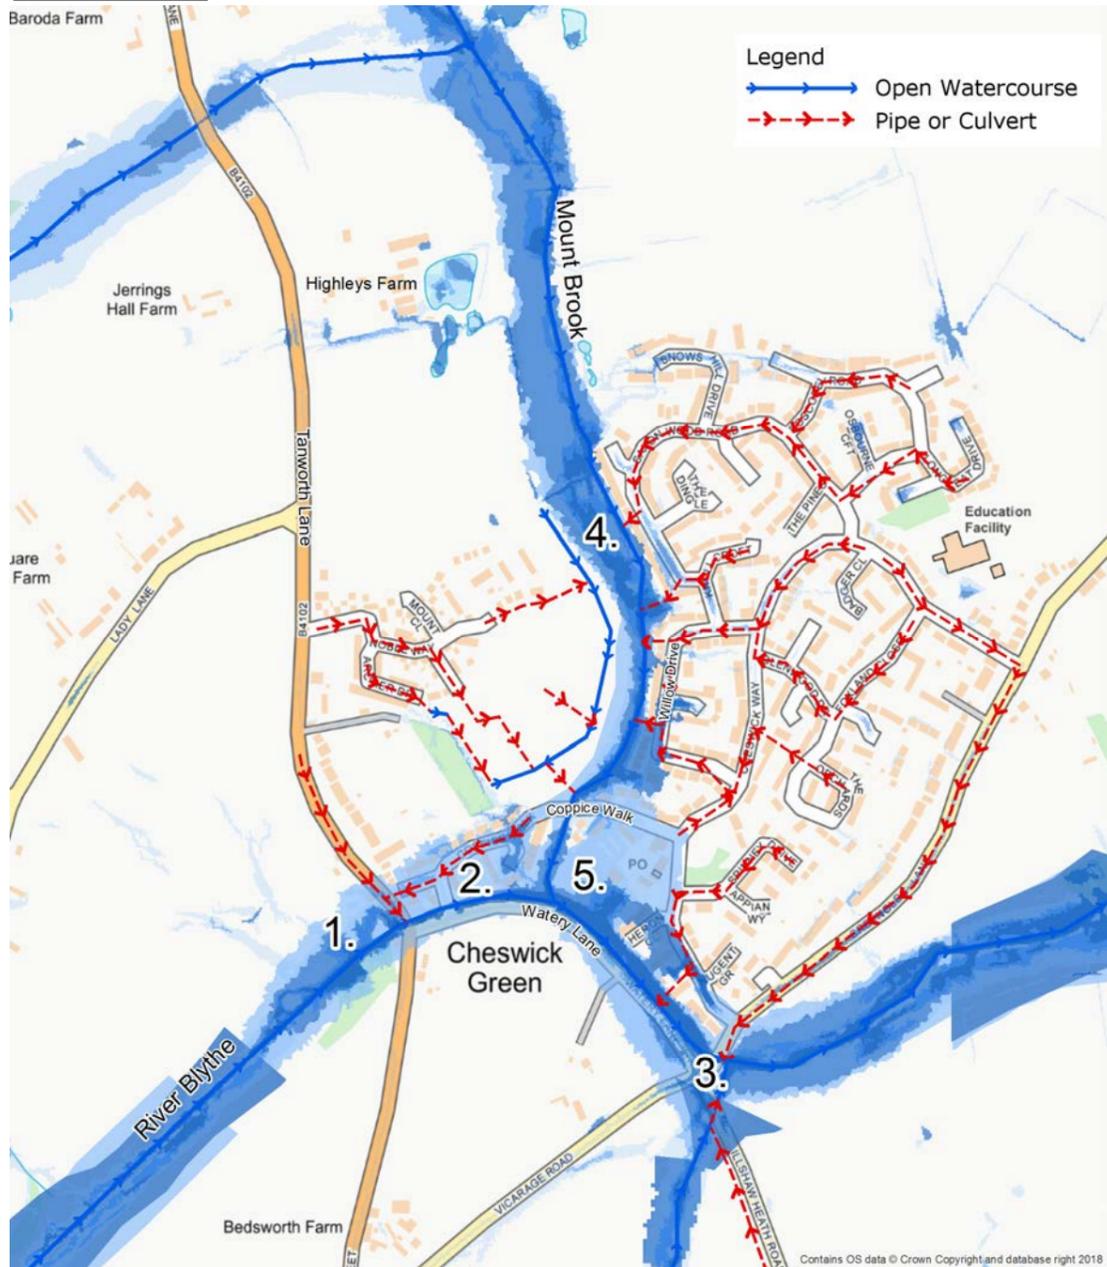
**Location plan**

<u>Surface Water/Overland Flow</u>	<u>Sewers</u>	<u>Main Rivers</u>	<u>Ordinary Watercourses</u>	<u>Other</u>
✓	✗	✓	✗	✗
Water flowed across the ground and was unable to enter watercourses or sewers.	There was no sewer flooding in the area.	Main Rivers were unable to cope with the amount of water flowing into them.	There are no ordinary watercourses in the area.	No other source was identified.

2. Flood risk associated with flooding from the River Blythe on Tanworth Lane, Coppice Walk and Watery Lane	Internal and external flooding of multiple properties was reported along Coppice Walk and Tanworth Lane due to flooding of the River Blythe. Residents reported a wave of water arriving after the initial rainfall had stopped. This may have been associated with flooding of the Stratford Upon Avon Canal at Lady Lane, which caused additional flows within the River Blythe.

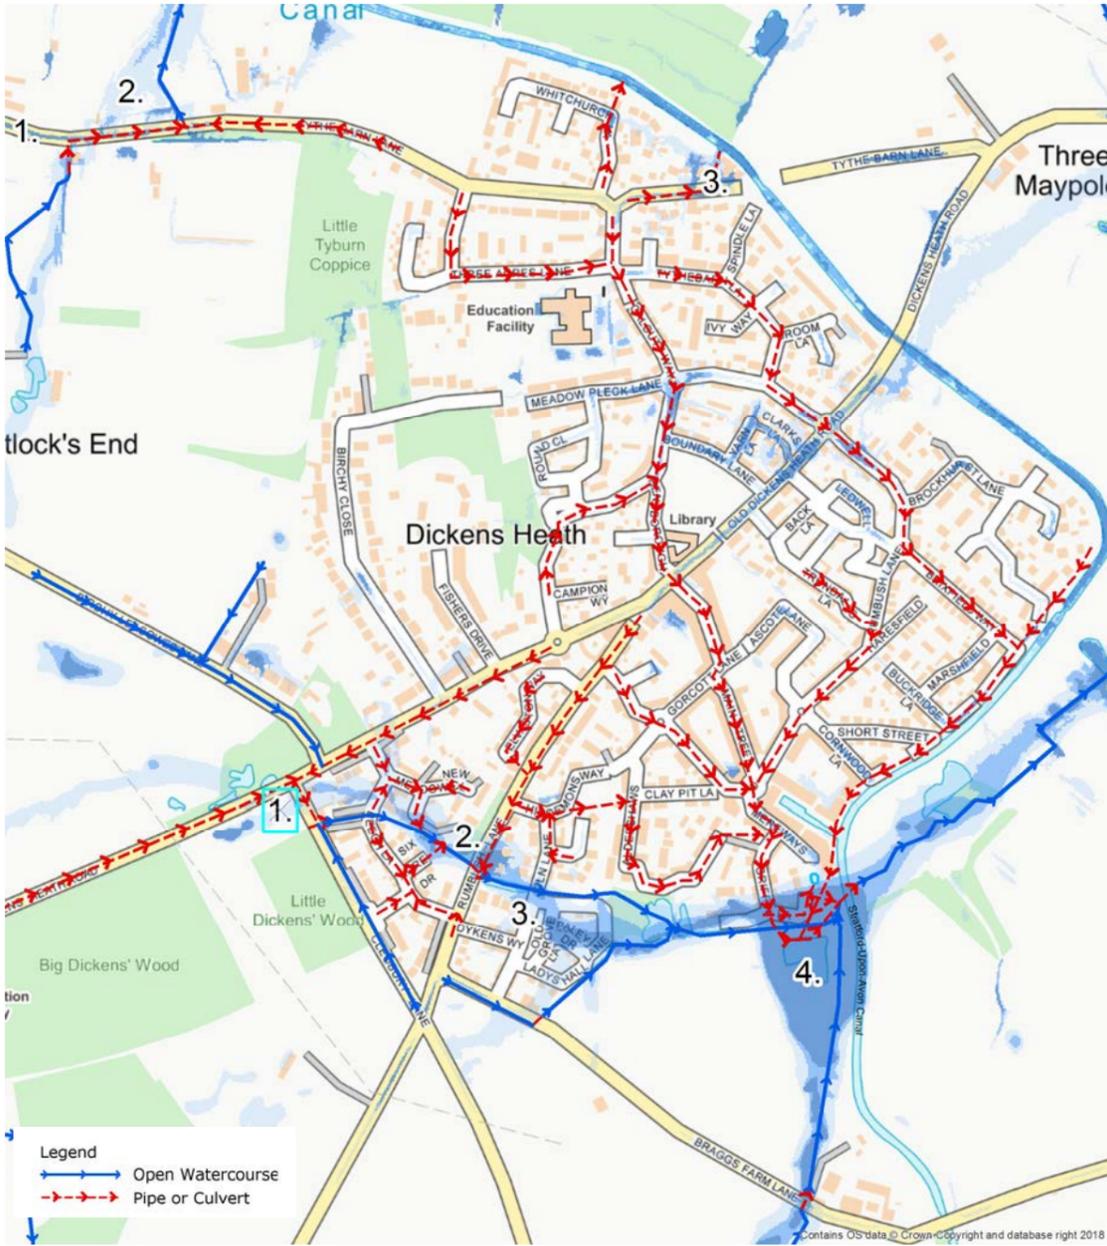
**Location Plan**

<u>Surface Water/Overland Flow</u>	<u>Sewers</u>	<u>Main Rivers</u>	<u>Ordinary Watercourses</u>	<u>Other</u>
✓	✓	✗	✓	✗
Water flowed across the ground and was unable to enter watercourses or sewers.	The local sewer network became blocked or overloaded.	There are no main rivers in the area.	Watercourses were unable to cope with the amount of water flowing into them	No other source identified.

3. Flood risk associated with the watercourse through The Paddocks development.	The balancing ponds were observed to be at or near capacity but with no flooding to properties on The Paddocks development.

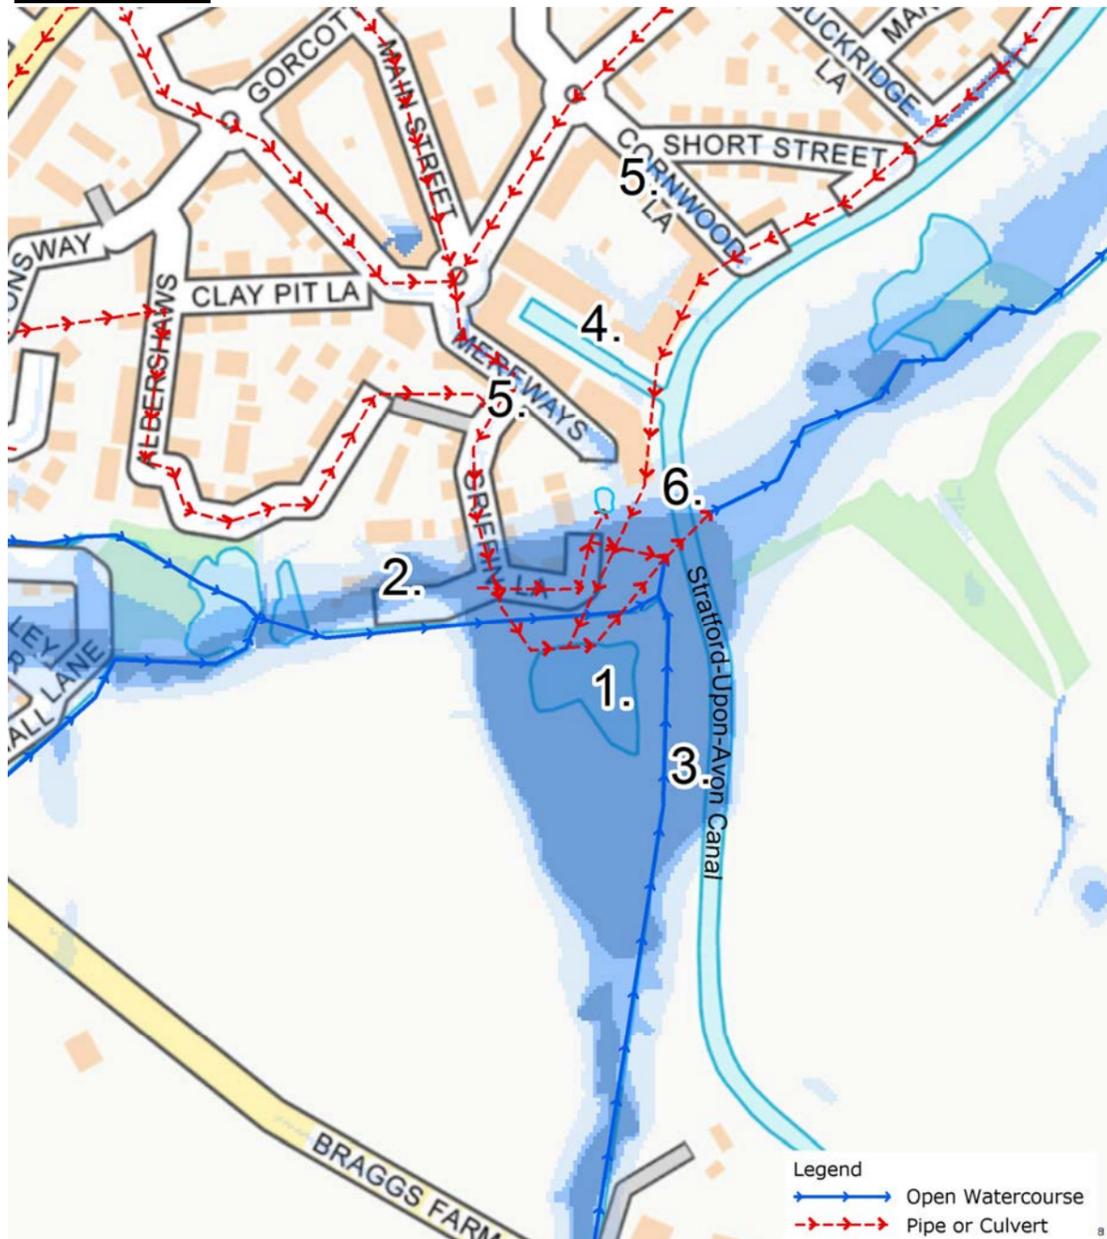
**Location Plan**

<u>Surface Water/Overland Flow</u>	<u>Sewers</u>	<u>Main Rivers</u>	<u>Ordinary Watercourses</u>	<u>Other</u>
✓	✓	✗	✓	✓
Water flowed across the ground and was unable to enter watercourses or sewers.	The local sewer network became blocked or overloaded.	There are no main rivers in the area.	Watercourses were unable to cope with the amount of water flowing into them	Flooding of the canal.

5. Surface water flood risk in the carriageway on Mereways and Cornwood Lane	Reports were received of flooding in the highway.
6. Flooding associated with the Stratford Upon Avon Canal	Reports were received of the canal flooding outside Waters Edge and Waterside causing internal flooding to multiple properties. This may have been associated with flooding of the Stratford Upon Avon Canal at Lady Lane, which caused additional flows within the River Blythe.

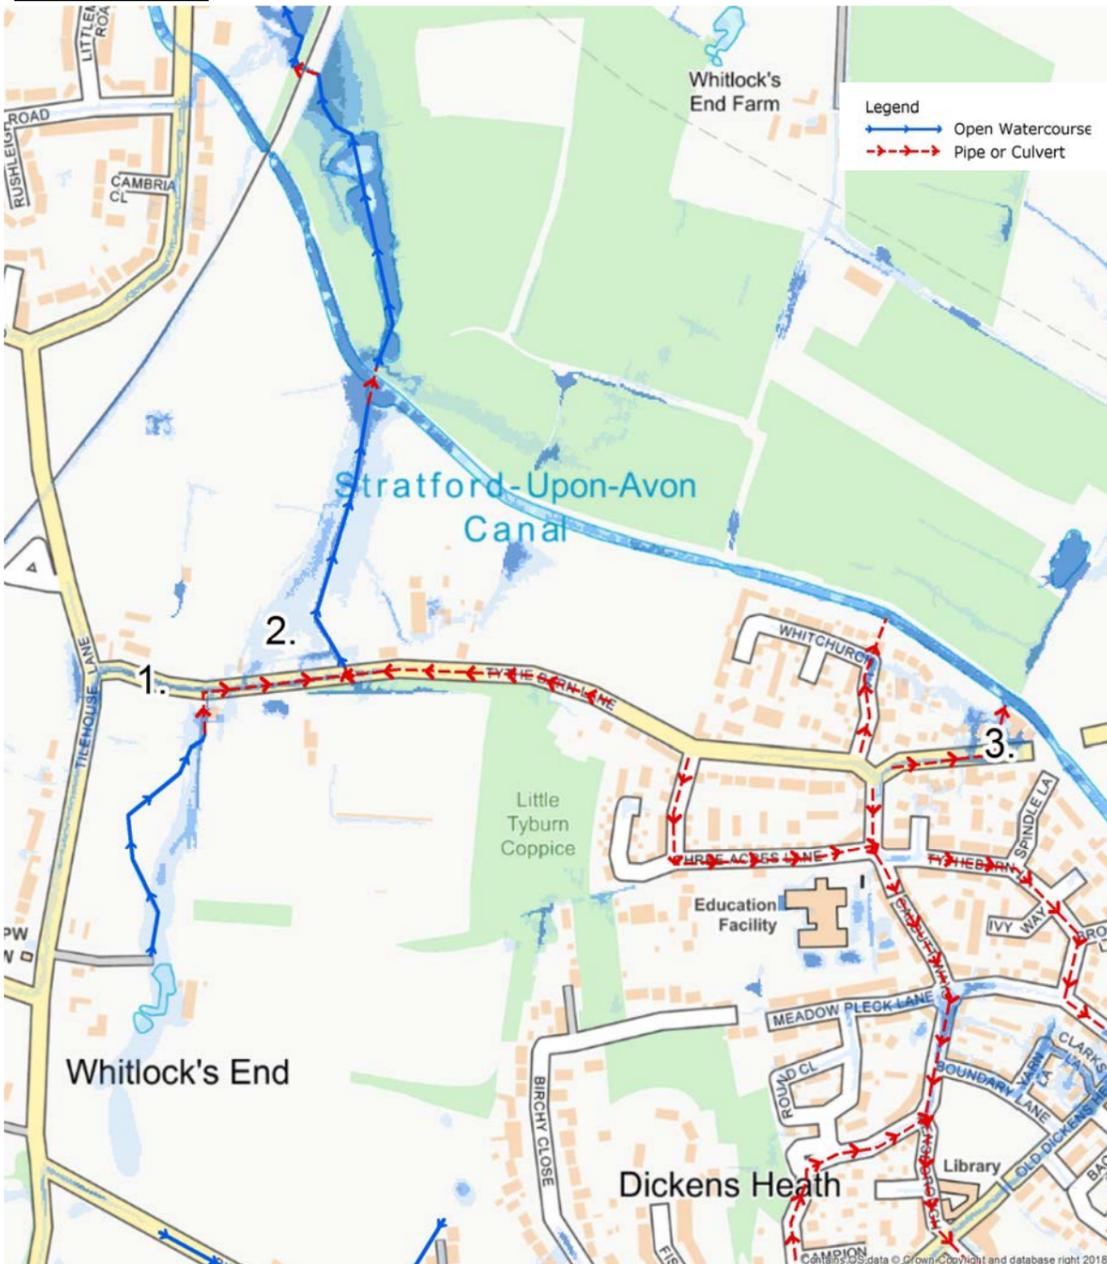
**Location plan**

<u>Surface Water/Overland Flow</u>	<u>Sewers</u>	<u>Main Rivers</u>	<u>Ordinary Watercourses</u>	<u>Other</u>
✓	✓	✗	✓	✓
Water flowed across the ground and was unable to enter watercourses or sewers.	The local sewer network became blocked or overloaded.	There are no main rivers in the area.	Watercourses were unable to cope with the amount of water flowing into them.	Another source has been identified.

3. At the eastern end of Tythe Barn Lane risk from surface water flooding is concentrated mainly in the carriageway immediately before the canal bridge but also exists from Whitchurch Lane to the canal bridge on a line behind Nos. 120-130 Tythe Barn Lane.	Reports were received of internal flooding to multiple properties on Tythe Barn Lane at this point as a result of the highway drainage and sewer network being overloaded. It is understood that the water level on the canal may have been higher than normal at the time, which may have caused the flooding as the outfall from the sewer network became restricted.

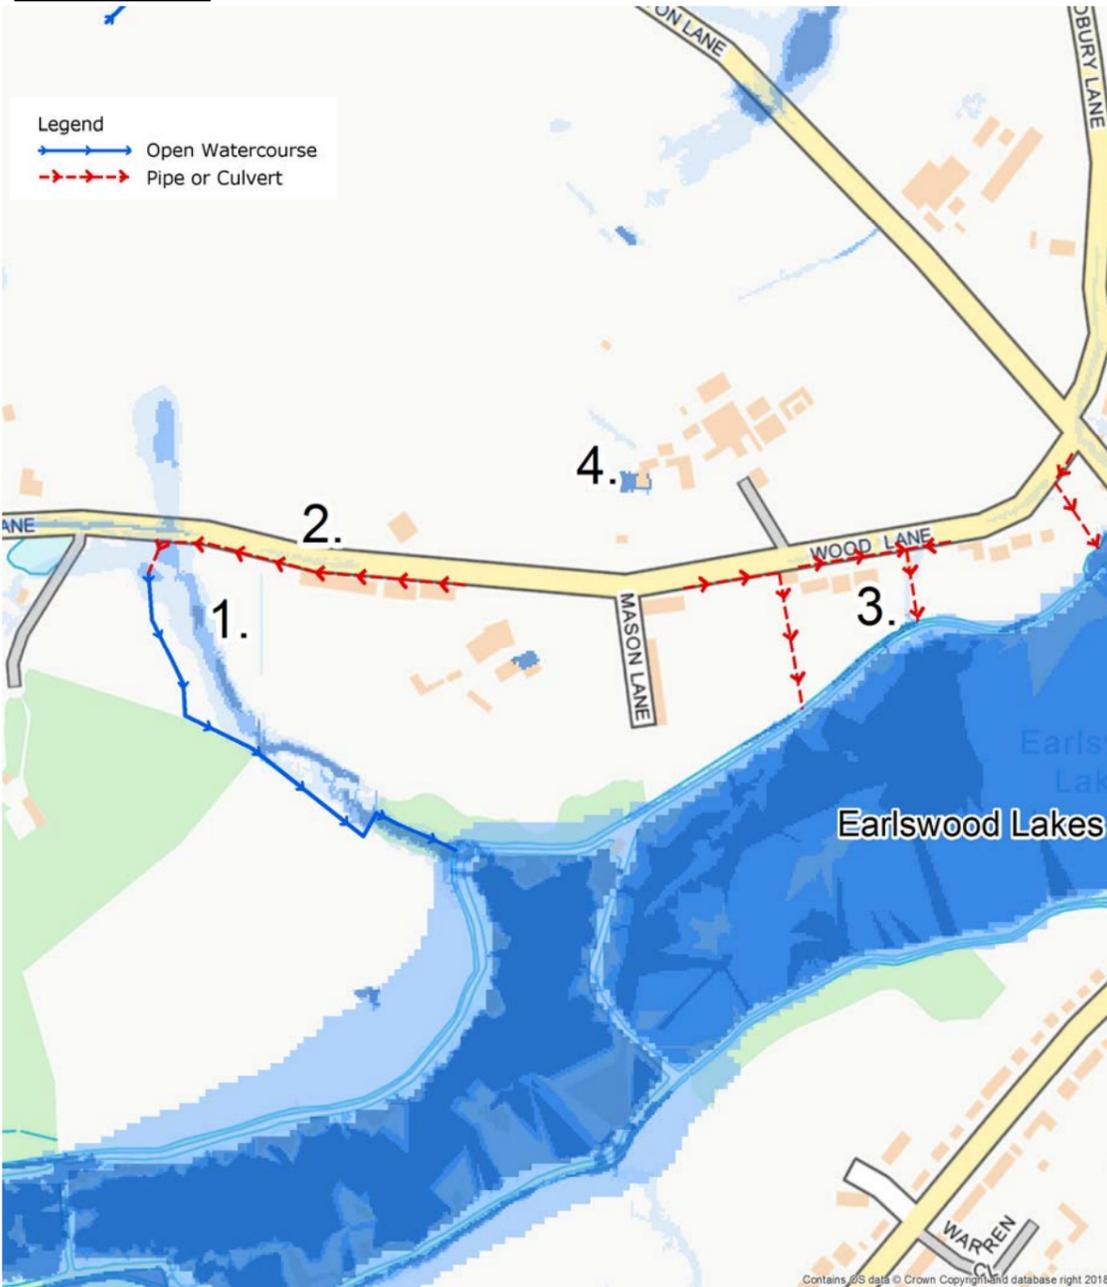
**Location Plan**

9 properties internally flooded	1 property externally flooded	8 garages flooded

<u>Description of area shown to be at risk</u>	<u>What happened on 27<sup>th</sup> May?</u>
1. Flood risk is shown on a flow route that is primarily associated with a watercourse that runs from land adjacent to Willow Tree Farm through to Earlswood Lakes.	Photo and video evidence of the event suggests that the cause of the flooding was overland flow from the surrounding area across fields and through properties on either side of Wood Lane. Whilst the flow of water would have tried to enter the highway drainage system, the system would have quickly become overwhelmed, before the water continued on a path towards the canal feeder.
