# Flood Investigation Report

## Various Locations, Solihull

**1<sup>st</sup> September 2015**

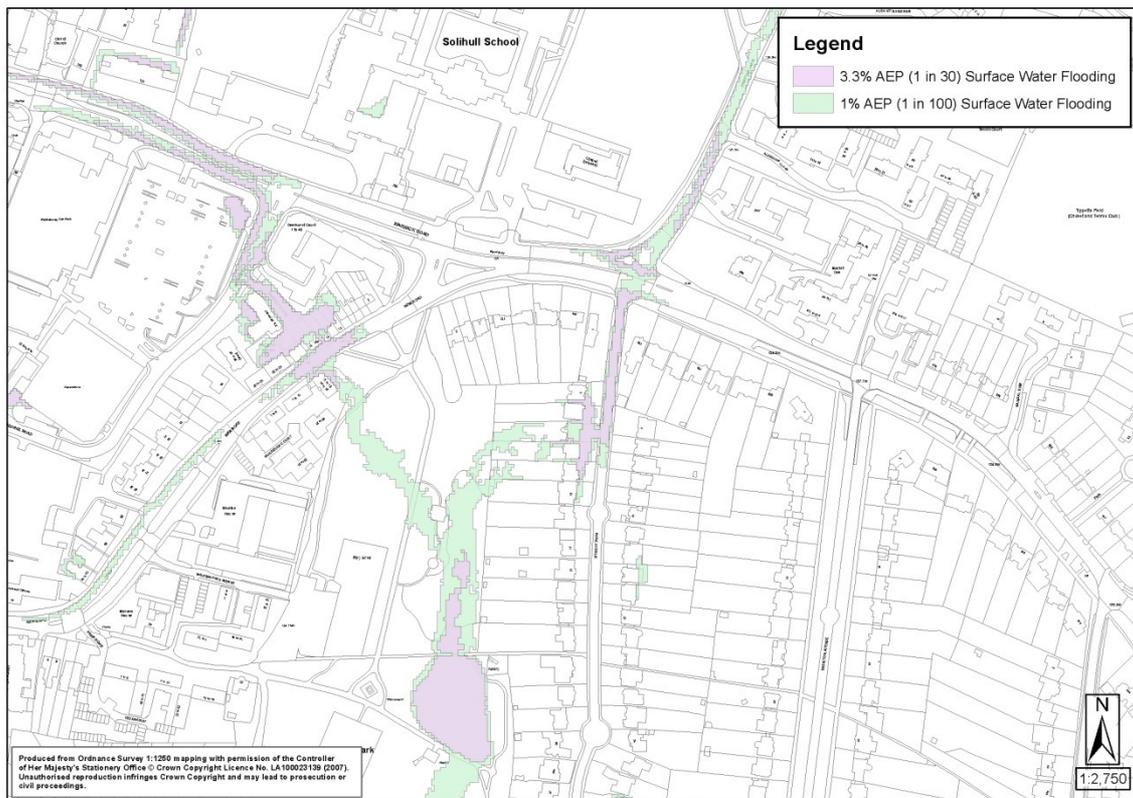
Figure 1 – Surface water flood risk within the New Road & Park Avenue Area, St Alphege

Mapping produced by the Environment Agency and held by Solihull MBC indicates a flood risk associated with surface water flooding. The extent of surface water flood risk is shown in Figure 1. As Figure 1 shows, flood risk can be found in the areas around Park Avenue and New Road, with extreme flow paths running through both areas and down to Malvern Park.

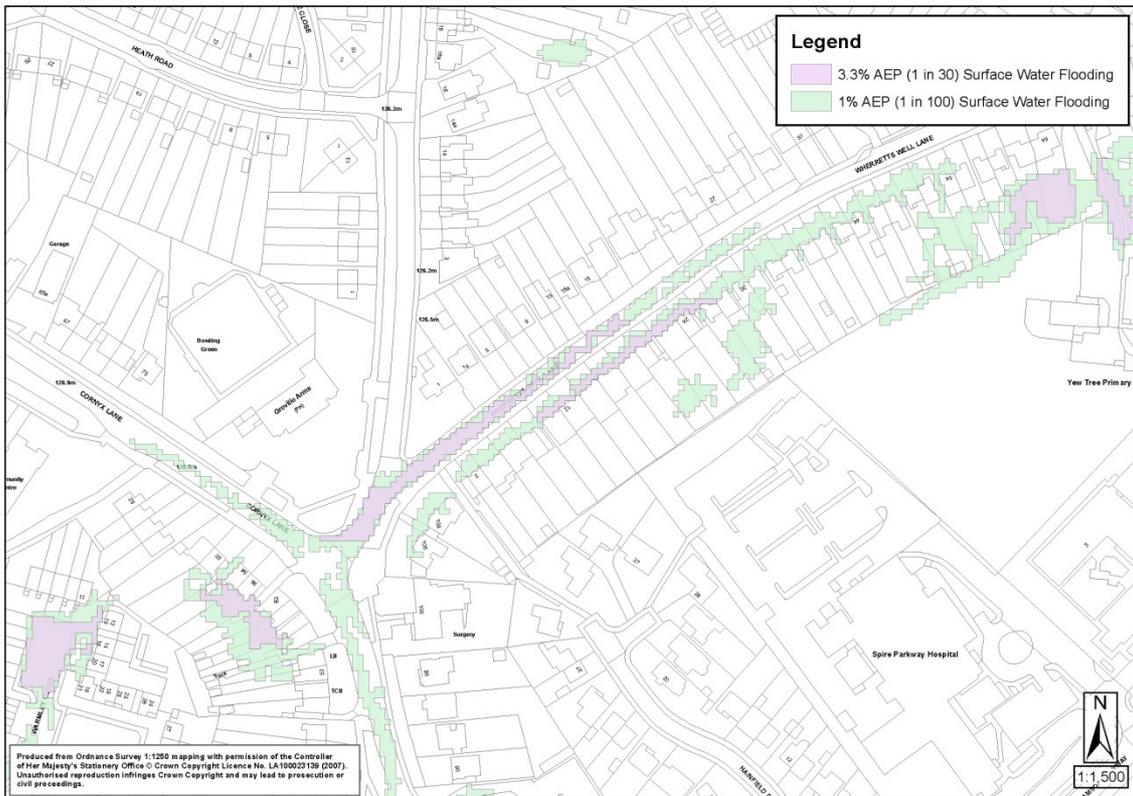
Figure 2 – Surface water flood risk within the Yew Tree Lane, Cornyx Lane and Wherretts Well Lane Area, Silhill.

Mapping produced by the Environment Agency and held by Solihull MBC indicates a flood risk associated with surface water flooding. The extent of surface water flood risk is shown in Figure 2. As Figure 2 shows, flood risk can be found in front and rear gardens of Wherretts Well Lane, Cornyx Lane and Yew Tree Lane. Flow paths can also be seen spreading along the various carriageways from the junction of Wherretts Well Lane, Cornyx Lane and Yew Tree Lane.

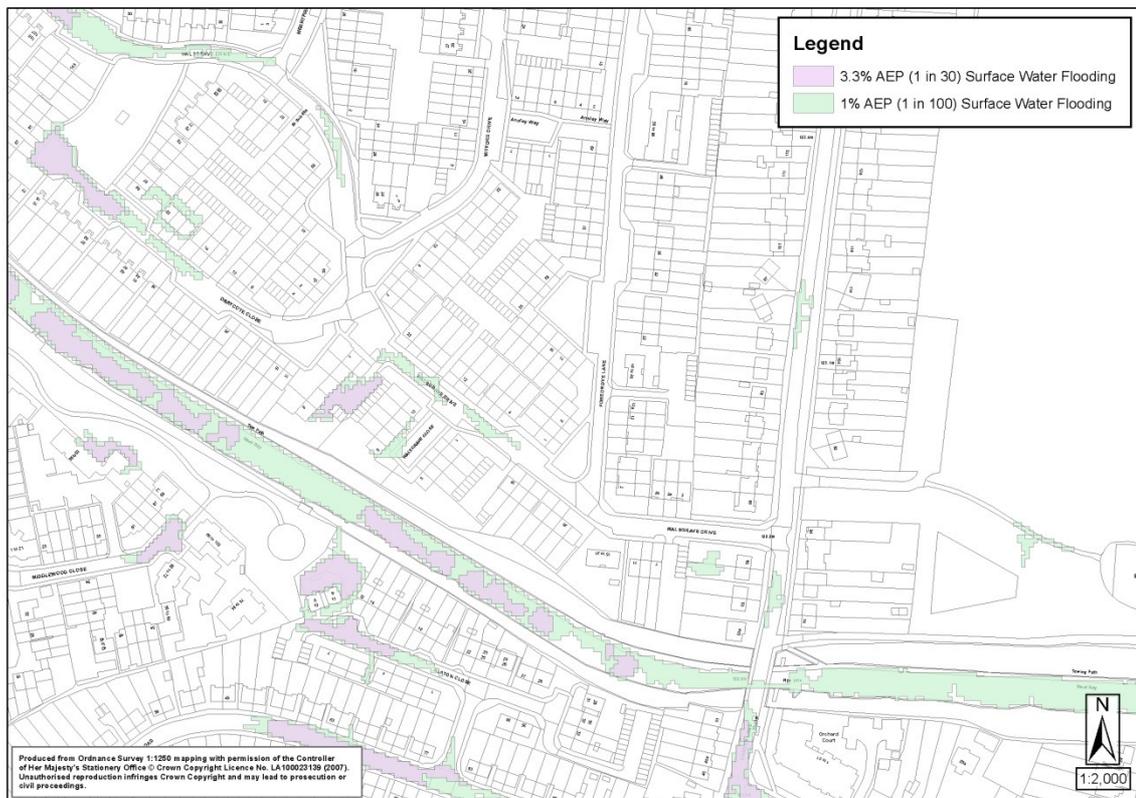
Figure 3 – Surface water flood risk within the Foredrove Lane, Damson Lane and Walsgrave Close area, Elmdon.

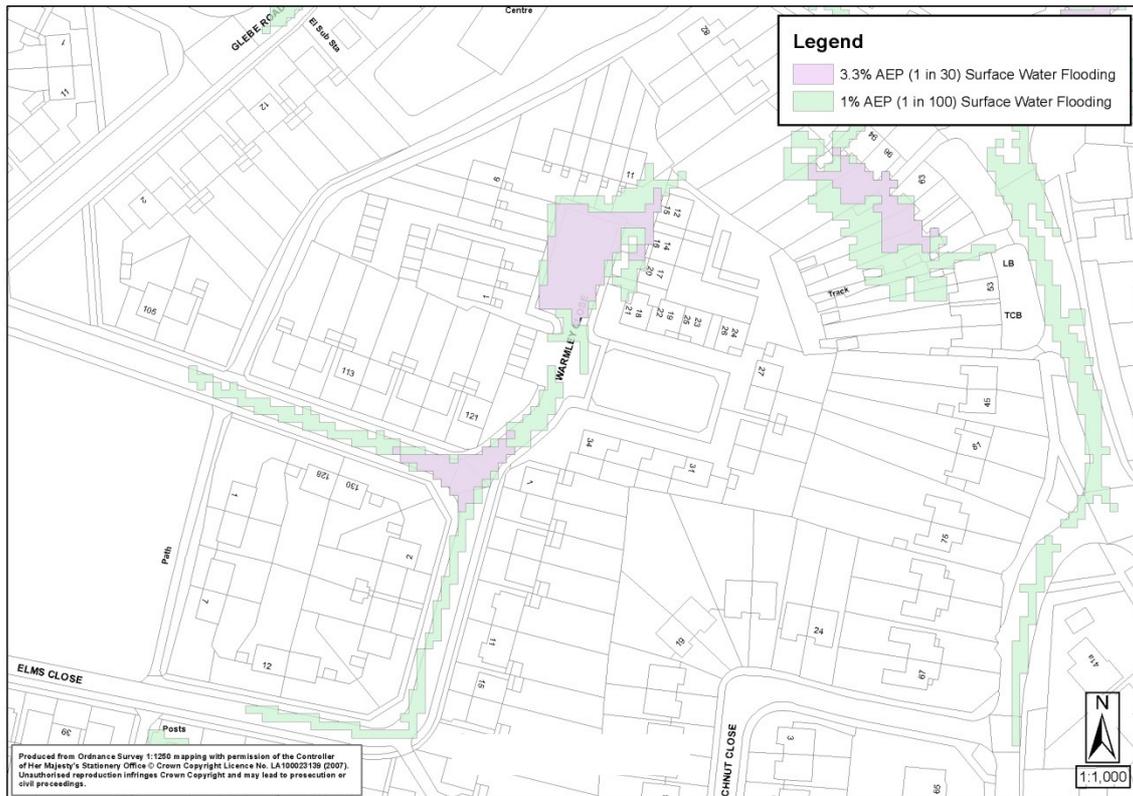
Figure 4 – Surface water flood risk within the Warmley Close area, Silhill.

Mapping produced by the Environment Agency and held by Solihull MBC indicates a flood risk associated with surface water flooding. The extent of surface water flood risk is shown in Figure 4. As Figure 3 shows, flood risk can be found in the areas of Warmley Close, Redlands Road and Elms Close. As can be seen, flood waters flow from Elms Close and Redlands Road into Warmley Close, with water accumulating at the bottom of the Close.

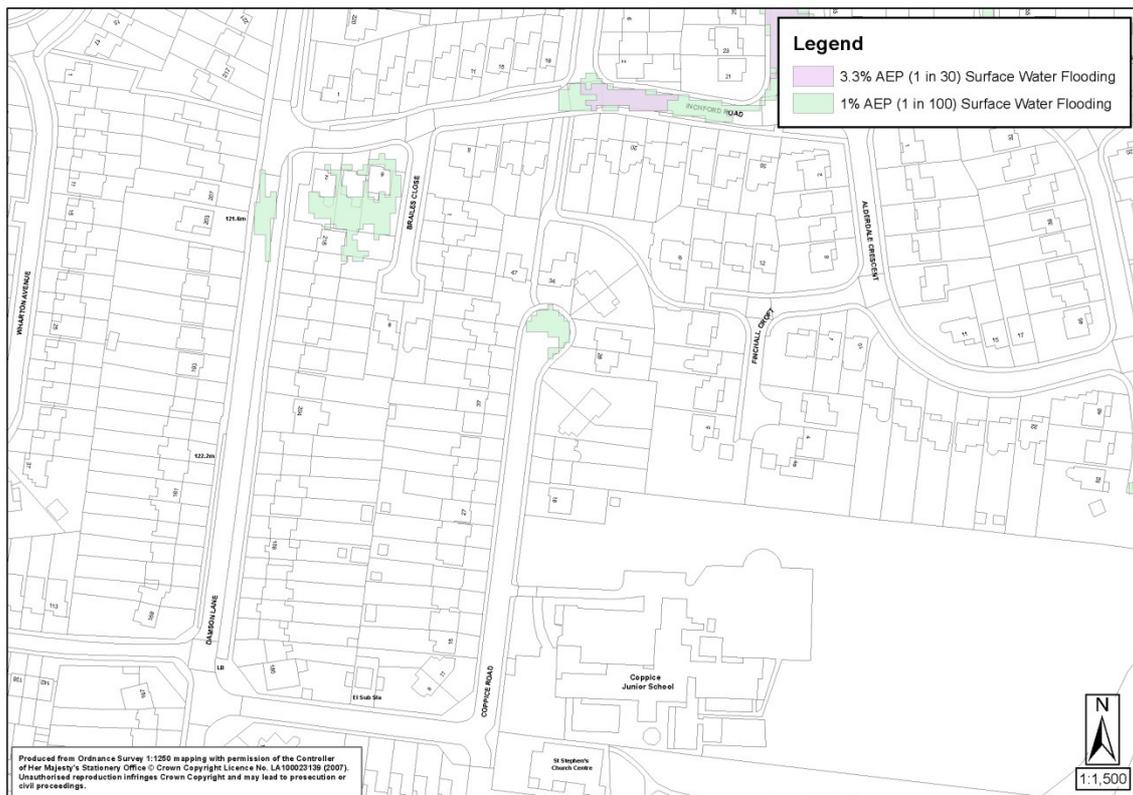
Figure 5 - Surface water flood map within the Coppice Road area, Elmdon
