Flood Investigation Report

**Knowle, Dorridge, Bentley Heath,
Monkspath and Hockley Heath**

25th June 2021

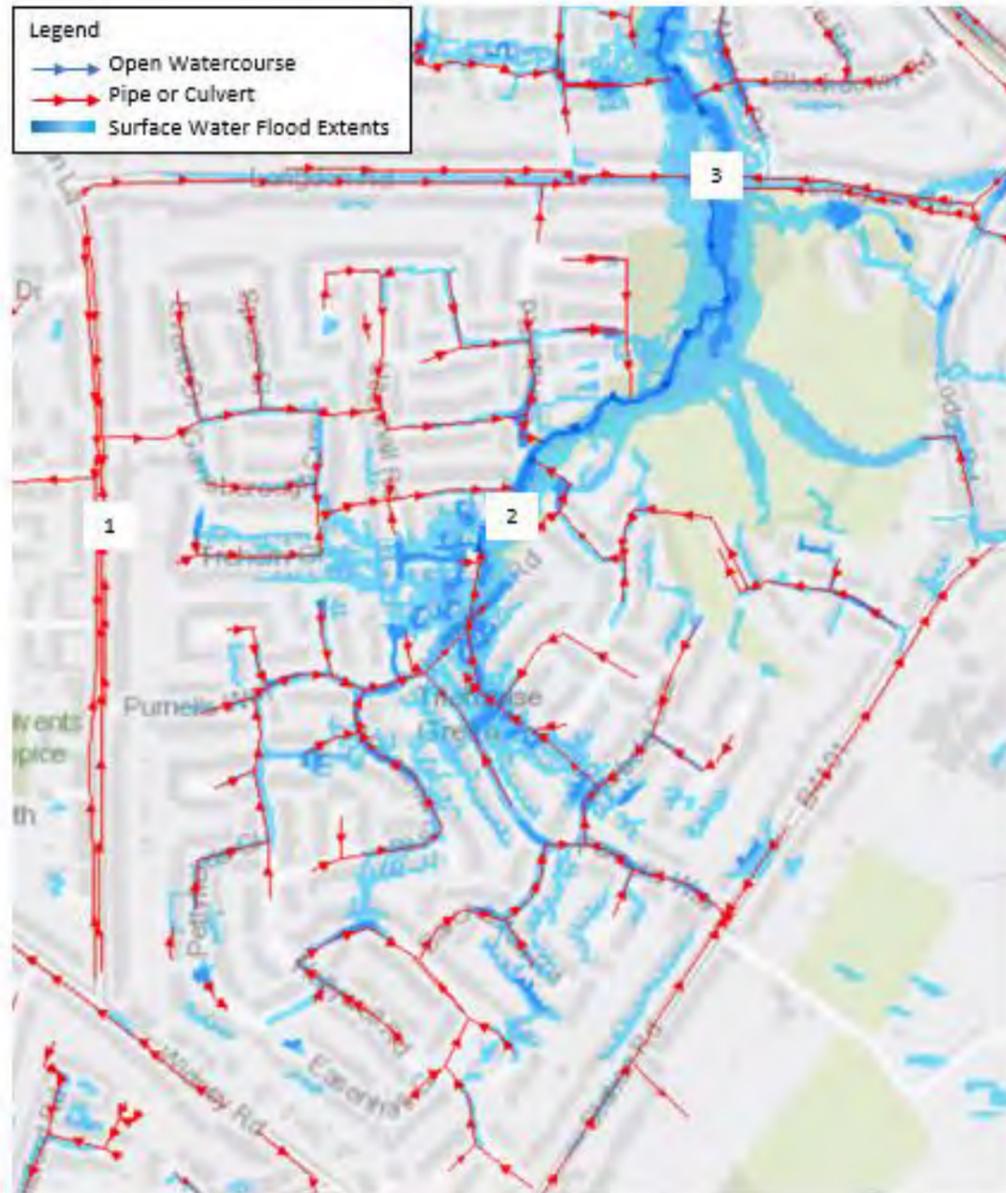
Location Plan

Mapping produced by the Environment Agency showing existing areas of risk of flooding from watercourses and also from surface water in the area. The mapping is based on computer models to assess long term risk and does not take into account factors such as blocked drains or burst pipes.

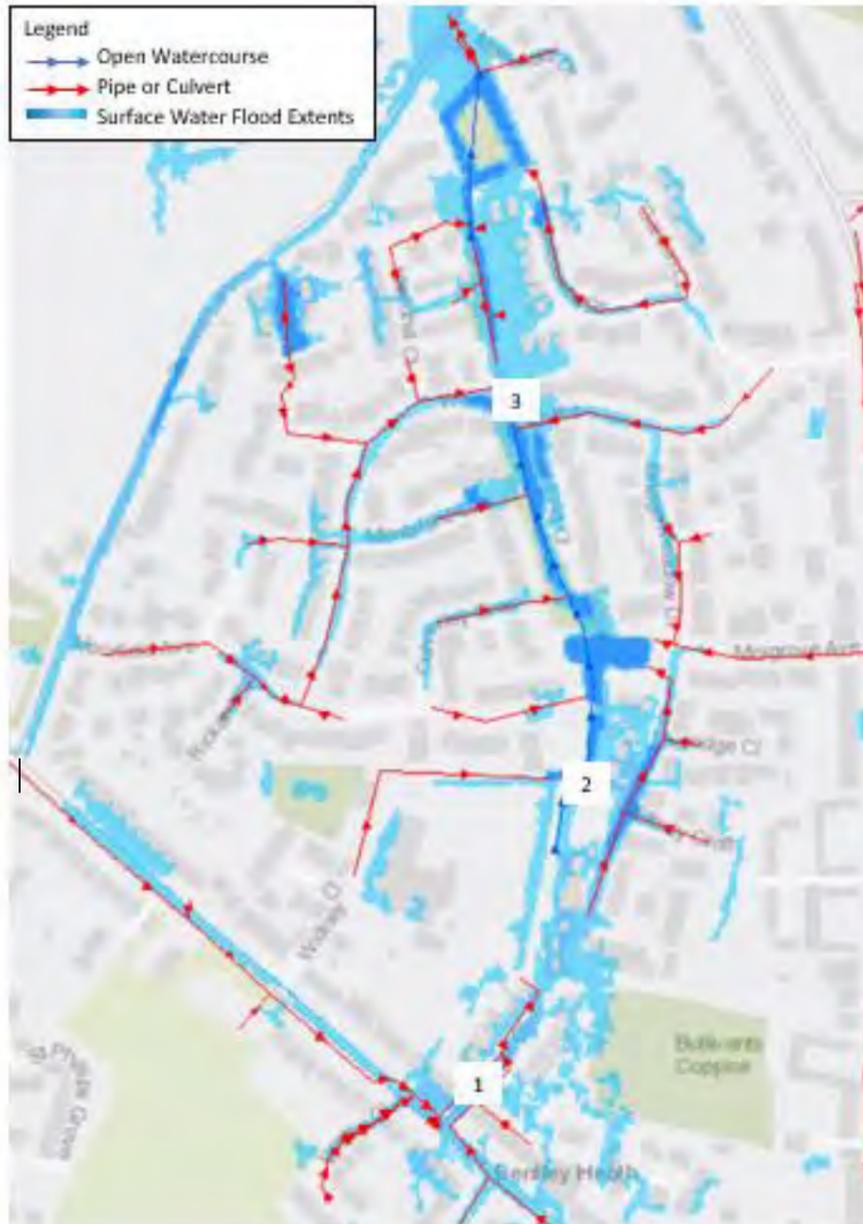
Location Plan

Mapping produced by the Environment Agency showing existing areas of risk of flooding from watercourses and also from surface water in the area. The mapping is based on computer models to assess long term risk and does not take into account factors such as blocked drains or burst pipes.

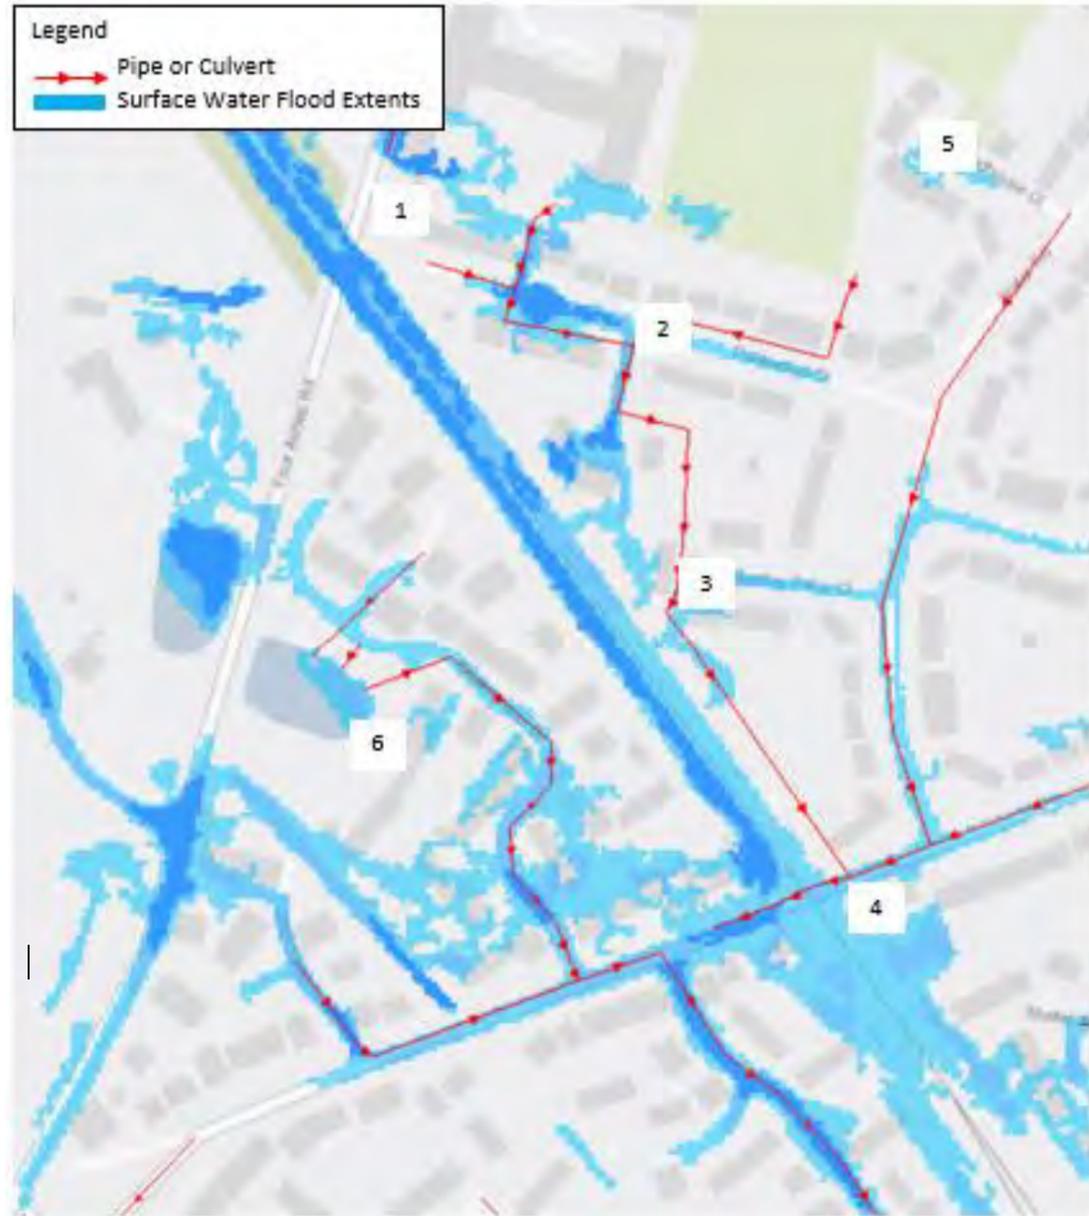
Location Plan

Mapping produced by the Environment Agency showing existing areas of risk of flooding from watercourses and also from surface water in the area. The mapping is based on computer models to assess long term risk and does not take into account factors such as blocked drains or burst pipes.

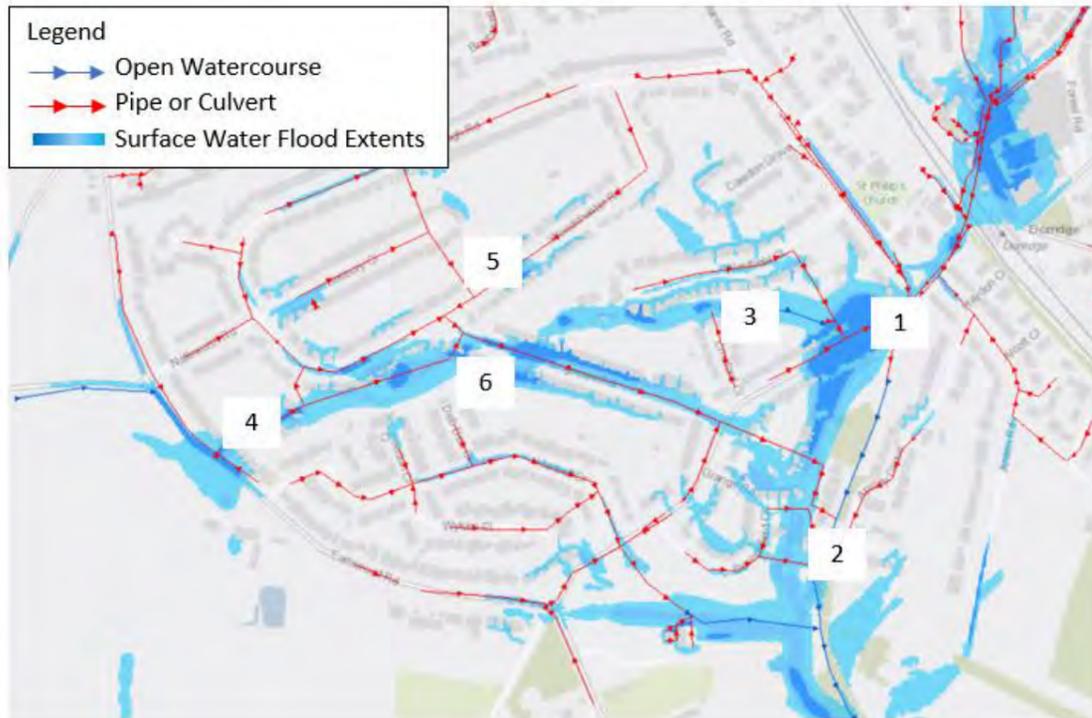
Location Plan

Mapping produced by the Environment Agency showing existing areas of risk of flooding from watercourses and also from surface water in the area. The mapping is based on computer models to assess long term risk and does not take into account factors such as blocked drains or burst pipes.

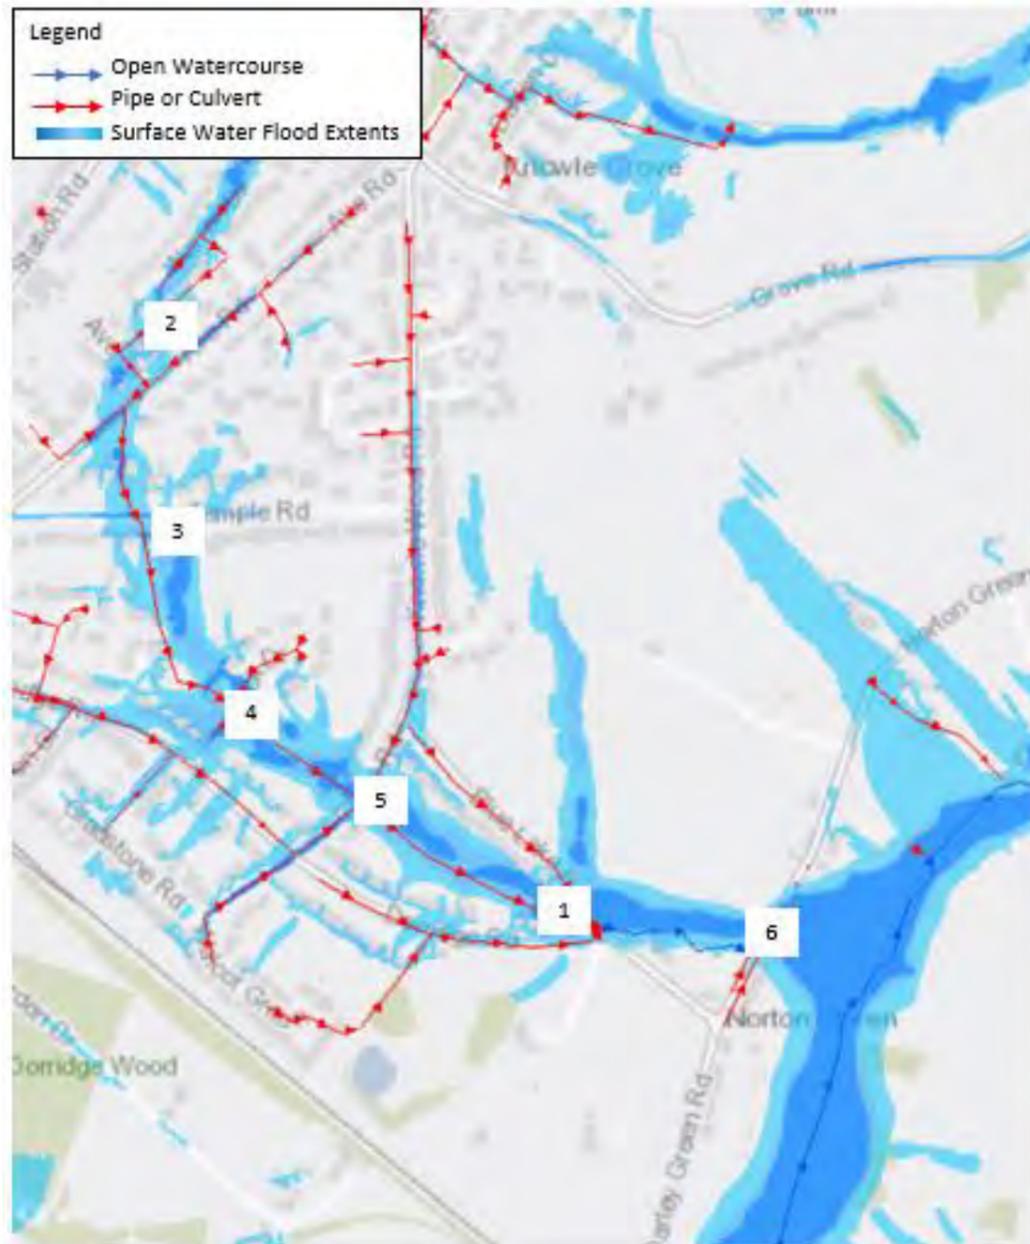
Location Plan

Mapping produced by the Environment Agency showing existing areas of risk of flooding from watercourses and also from surface water in the area. The mapping is based on computer models to assess long term risk and does not take into account factors such as blocked drains or burst pipes.

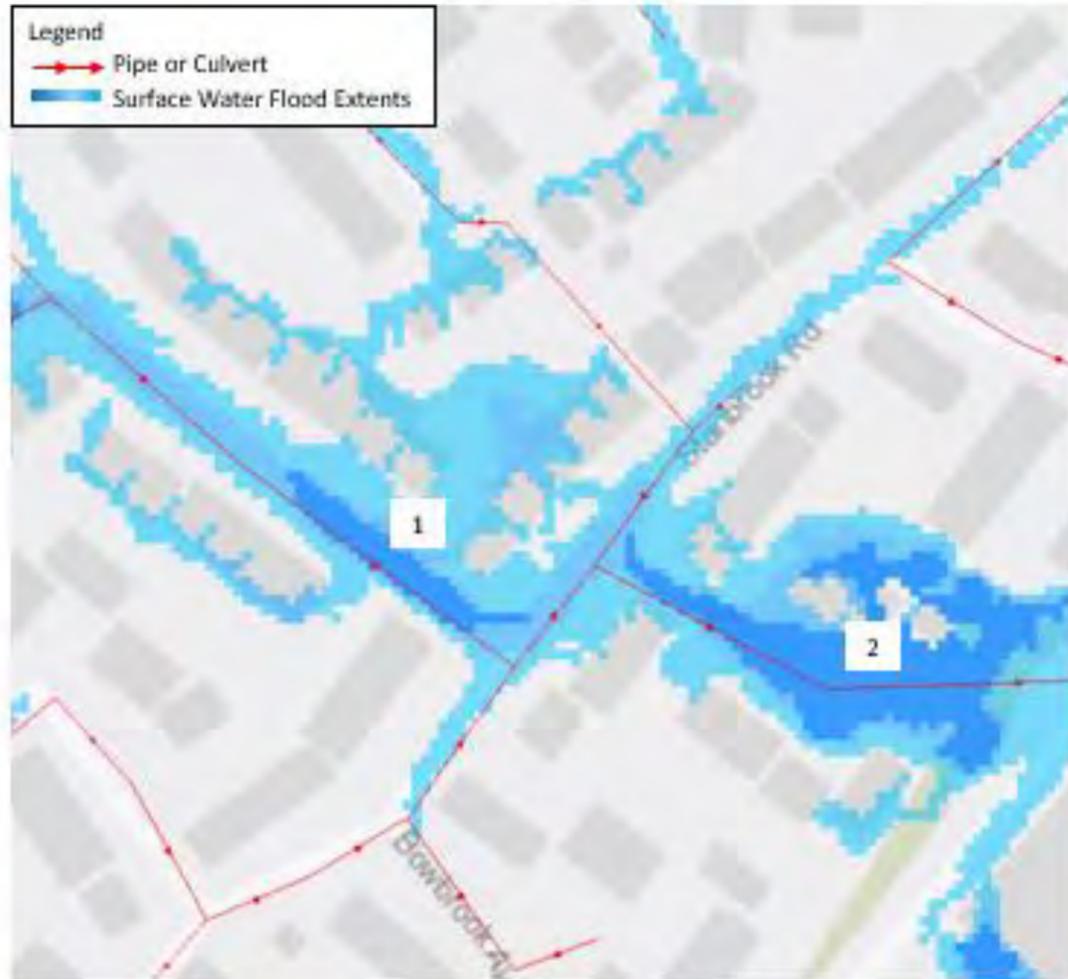
Location Plan

Mapping produced by the Environment Agency showing existing areas of risk of flooding from watercourses and also from surface water in the area. The mapping is based on computer models to assess long term risk and does not take into account factors such as blocked drains or burst pipes.
