**HERITAGE IMPACT ASSESSMENTS
SOLIHULL METROPOLITAN BOROUGH COUNCIL
LOCAL PLAN REVIEW**

**REPORT No 4: SITE 12 DOG KENNEL LANE, SHIRLEY
MARCH 2019**

HERITAGE IMPACT ASSESSMENT: SITE 12 – DOG KENNEL LANE, SHIRLEY

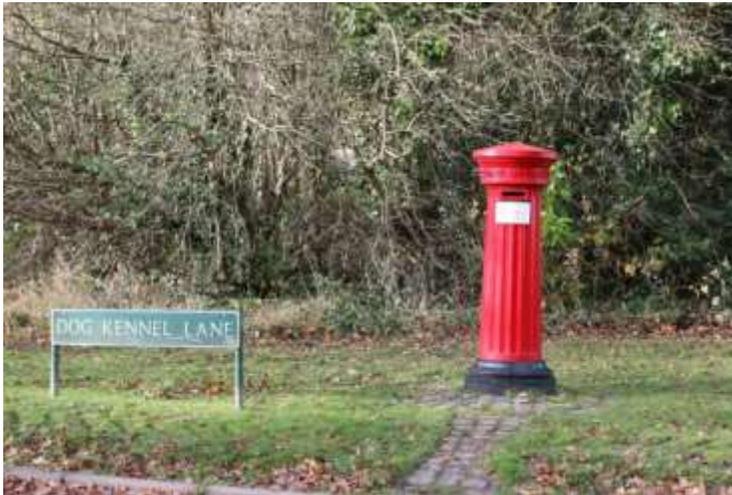
Figure 11 Grade II Listed Pillar Box at east end of Dog Kennel Lane

2. Pillar box. Circa 1857 for the Birmingham District of the GPO. Cast iron. Fluted column with taper towards top on moulded base. Moulded top with shallow cone and moulded band marked VR and POST OFFICE and with royal crests. Horizontal aperture below. Manufactured by Smith and Hawkes Ironfoundry, Broad Street, Birmingham.

4.7.4 The significance of the listed pillar box will not be affected and as such it provides no constraint to development of the site.

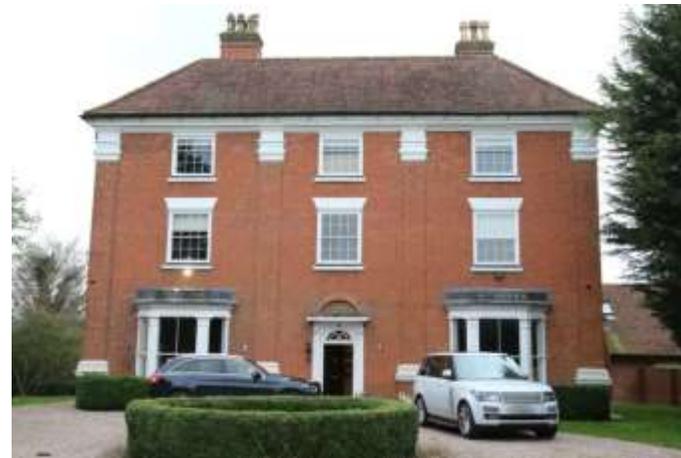
Figure 12 Light Hall north front elevation

- 4.6.9 Light Hall itself is of considerable interest. The front north elevation is elegant with raised brick pilasters with moulded plinths and capitals and a moulded cornice. Its appearance is different to that shown in the 1794 survey (compare Figures 2 and 9). The ground floor sash windows have been replaced by bays and a door case with scrolled fanlight, flat pilasters, moulded brackets and flat hood has been installed. The original fanlight has been replaced although the original semi-circular brick arch remains above the door case. The rear elevation has sash windows at first and second floor, the outer sashes also having sidelights. Ground floor windows are casements and a late C20th open porch has been added (Figure 11). The east side elevation has different casement window styles at ground floor and

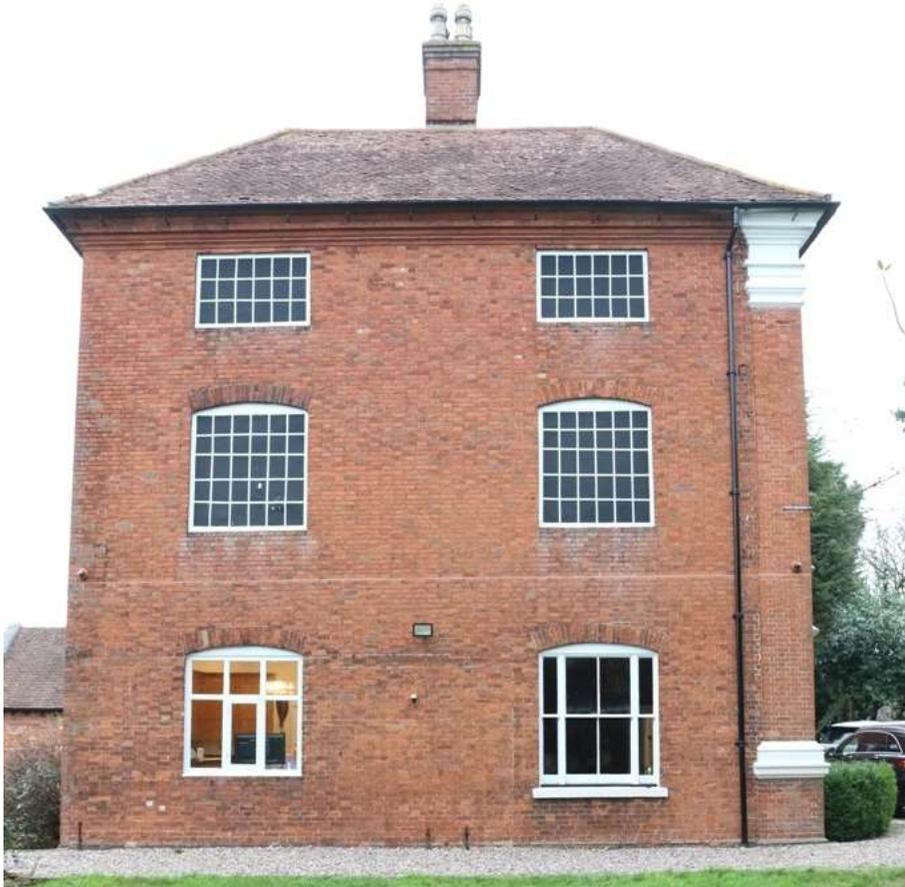
Figure 14 Light Hall; east side elevation

the first and second floor windows are blind, painted windows in imitation of sashes beneath shallow curved brick arches (Figure 12). On the west side elevation, all windows are blind, painted as sashes but there are no arches and the brickwork above the windows is painted as lintels (Figure 13).

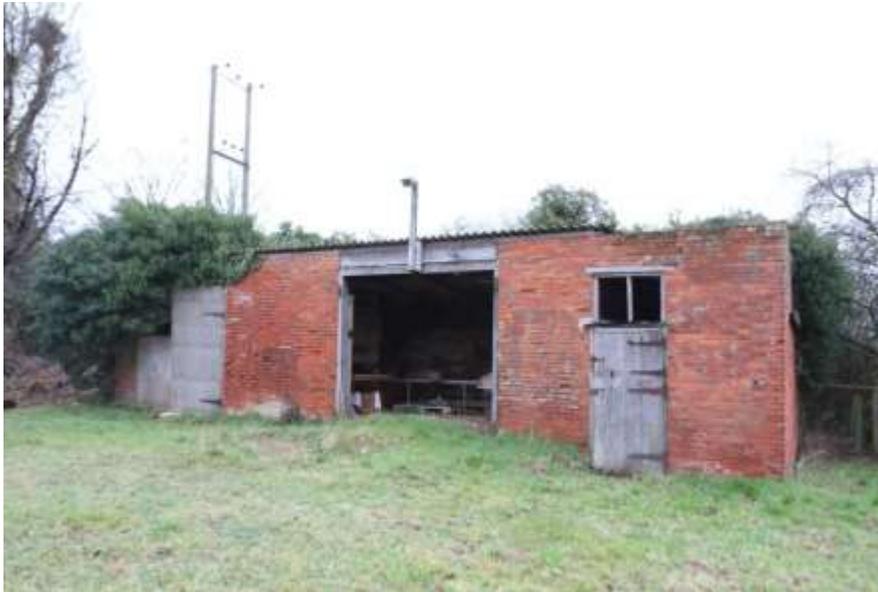
Figure 16 Light Hall; outbuilding adjacent to former walled garden

- 4.6.10 Beyond the drive, south-east of the house are the remains of an outbuilding with a short section of wall at its north-west corner. West of this wall are the remnants of a low wall, now obscured by undergrowth and ivy but with an opening for a gate just visible. This building and the walls are the ground floor of the outbuilding shown to the left of the main house in Figure 5, which also shows a wall with battlements or crenellations. If this feature is still extant it is covered with ivy and hence is obscured. The walled garden which is shown as parcel 265 on the Tithe map and is shown on the 1884 Ordnance Survey map had paths dividing the walled garden into four compartments. It is not clear that any other remnants of the garden wall or the paths remain visible.
